Water Facts #6

Protecting Wells with Sanitary Well Caps and Grouting

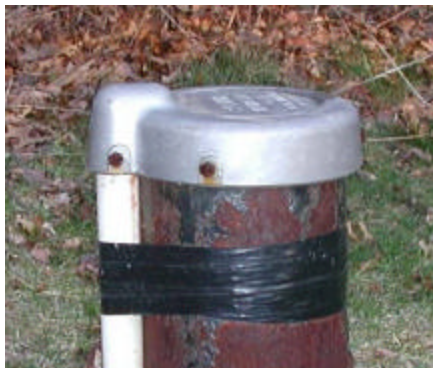
Figure 1. A standard well cap similar to those found on most Pennsylvania wells (note the bolts around the outside of the well cap).

Most existing and new wells in Pennsylvania have a standard well cap similar to the one shown in Figure 1. Standard well caps usually have bolts around the side of the cap that loosely hold the cap onto the top of the casing. The small airspace between the well cap and the casing can allow for insects, small mammals, or surface water to enter the well.

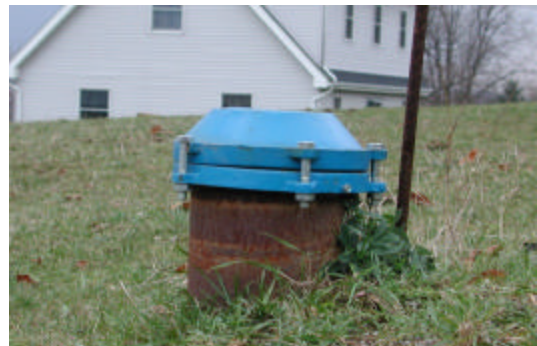
Figure 2. A sanitary well cap installed on a well casing. Note the bolts on the top rather than around the sides of the cap.

A “sanitary” well cap (sometimes referred to as a “vermin-proof” well cap) looks similar to a standard well cap but usually has bolts on the top of the well

cap as shown in Figure 2. Most sanitary well caps include an airtight rubber gasket seal to prevent insects, small mammals, or surface water from entering the well and a small, screened vent to allow for air exchange (Figure 3).

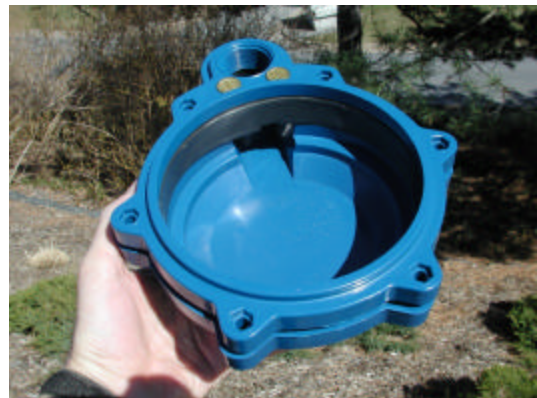
Figure 3. A sanitary well cap showing the rubber gasket, hole for electrical conduit, and screen holes for ventilation.

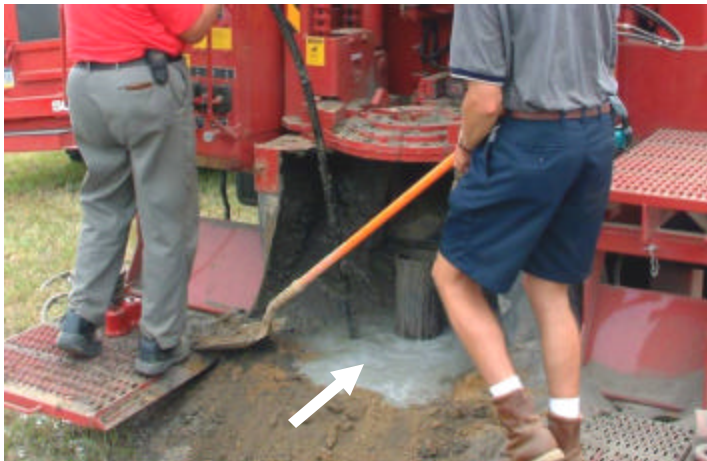
Figure 5. Well drillers use a tremie pipe to pump grout into the well. Note that the grout is now appearing at the surface of the ground around the well casing—see arrow (Photo by Dr. Todd Giddings).

pumped into the annular space starting from the bottom of the casing using a tremie pipe until it appears at the surface of the ground (Figure 5). Grout is usually not used on private wells in Pennsylvania unless it is required by local ordinances or requested by the homeowner.
